# Vegetation Succession, Avian Response, and Habitat Management Following Beneficial Placement of Dredged Material in a Coastal Marsh Area in New Jersey

**Samantha Collins**

Research Scientist, The Wetlands Institute  
scollins@wetlandsinstitute.org

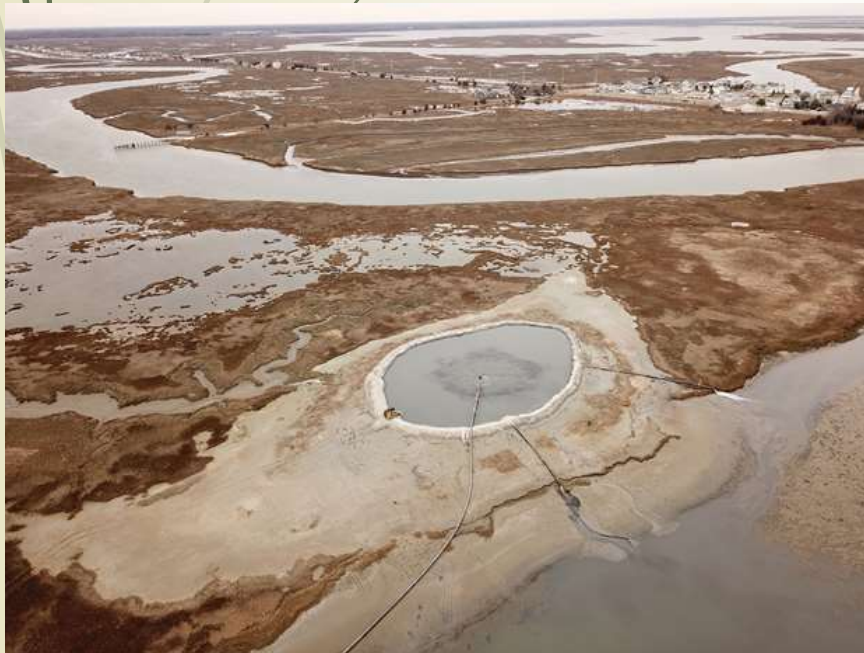
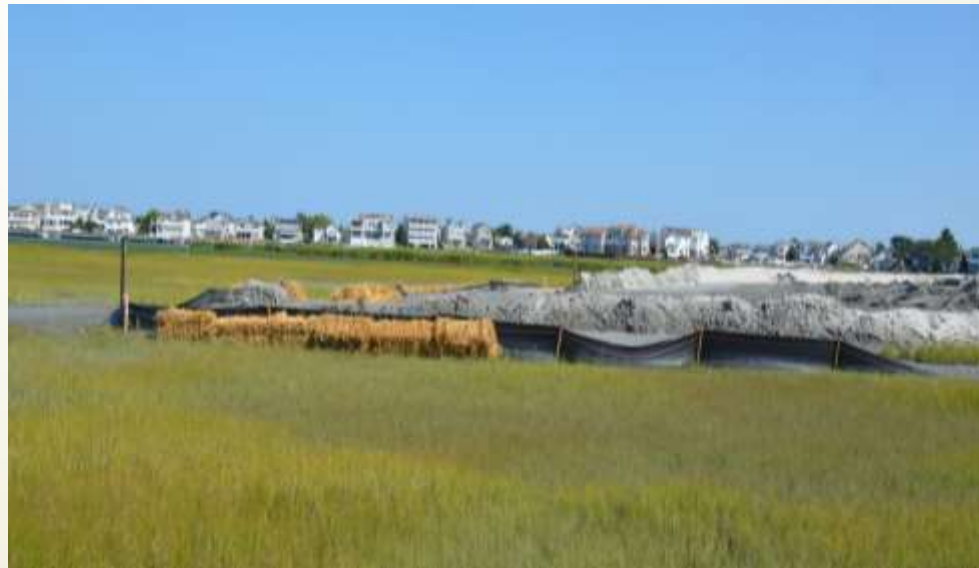
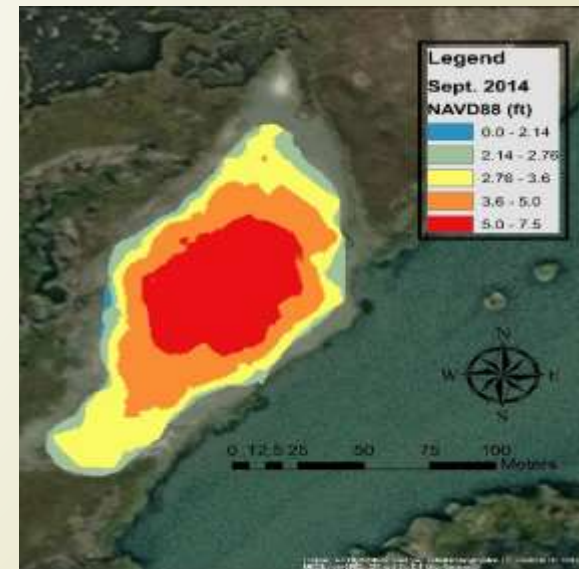
## Ring Island Elevated Nesting Habitat (ENH)

Construction considerations	NAVD88
Set target above MHHW	2.1 ft
Habitat above spring tide	3.6 ft
Habitat above storm flood elevations	5.5 ft
Allow dewatering, compaction, elevation loss	6.0 ft

- August - created to provide nesting habitat for Black Skimmers
- 1 acre, 6000 cy dredged material
- 96% sand from NJ Intracoastal Waterway shoal
- Near legacy placement
- Open, sparsely vegetated habitat above spring high tide
- Protected from predation and disturbance

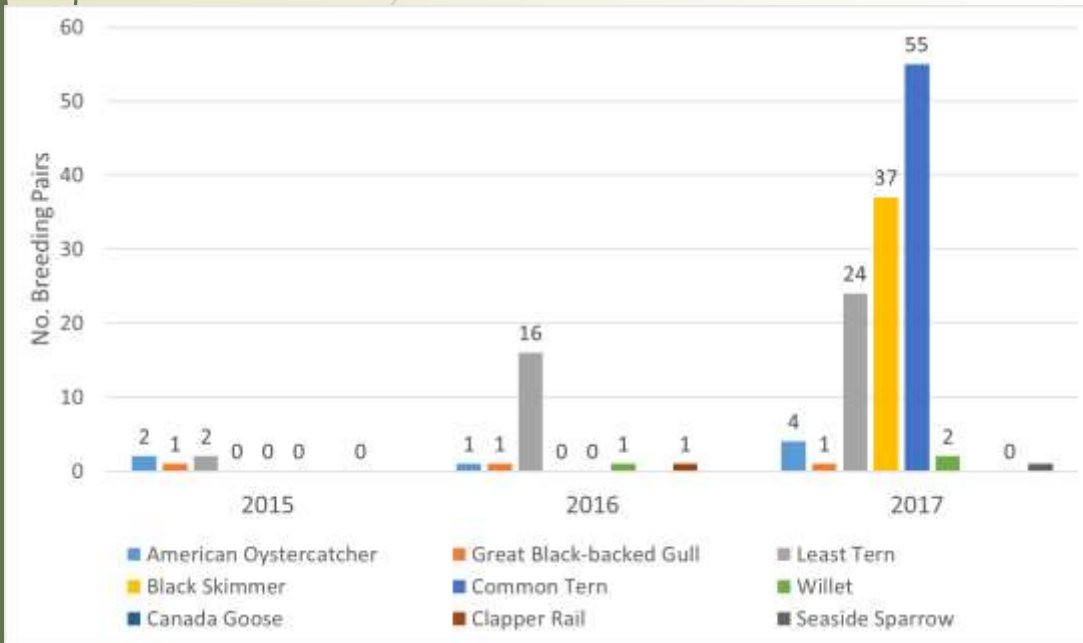
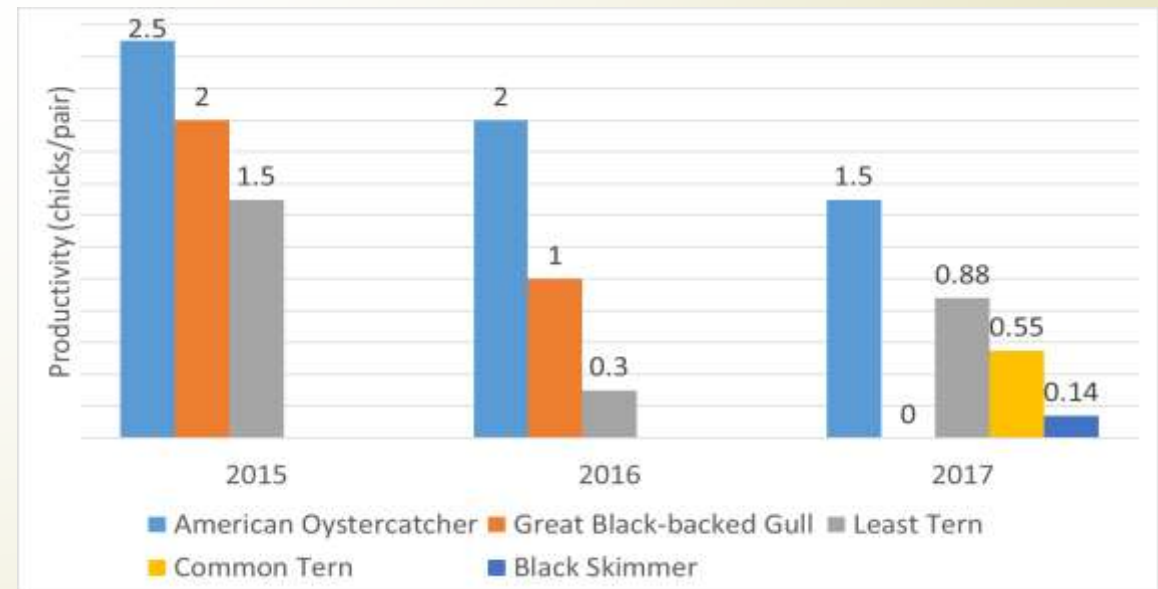
# Ring Island REPRODUCTIVE SUCCESS

- Highest diversity of nesting species and highest number of breeding pairs in 2017 (~2.5 years after initial placement)
- Lower productivity for nesting species by 2017

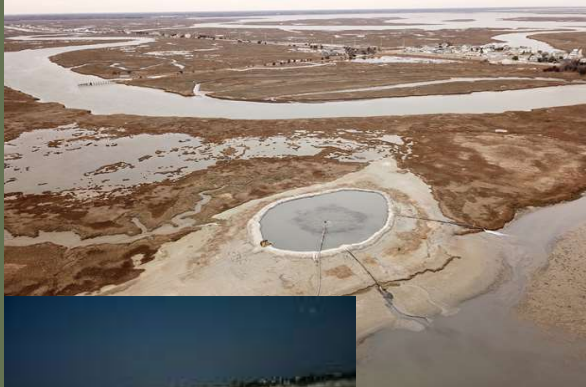
# Ring Island Elevated Nesting Habitat (ENH)

- Renourishment of ENH habitat – March 2018
  - 1,200cy sandy dredged material, berm existing material
  - 5.5' ecological target, 6.5' construction target
  - ~3.5 years after initial placement
  - Maintain vegetation around perimeter and disturb vegetation establishing on platform of ENH
  - Highest concentration of nesting birds but lower productivity for all species compared to 2017

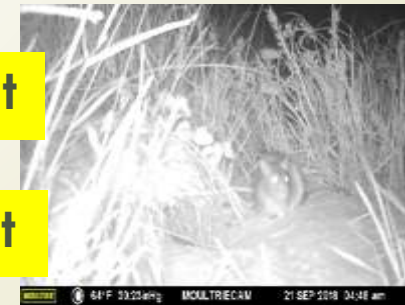
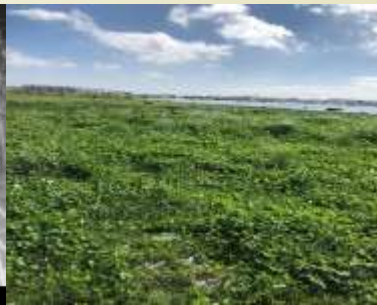
➤ Small mammals established on habitat

➤ Increased vegetation cover on habitat

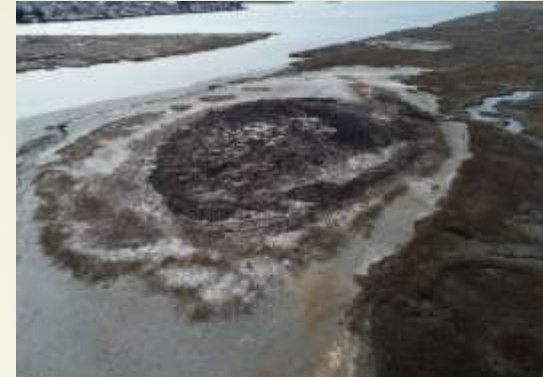
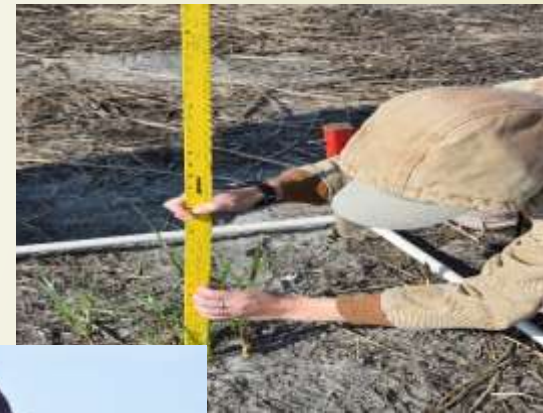
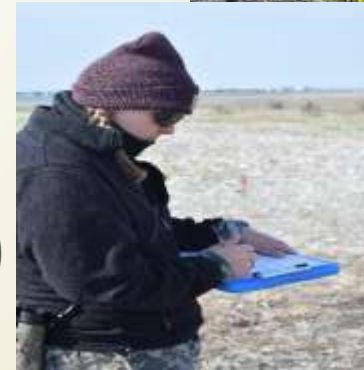
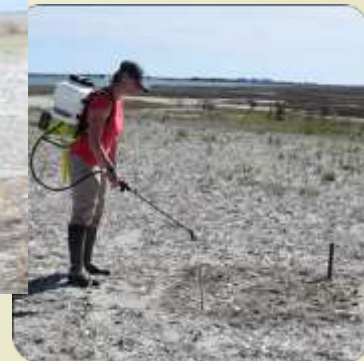
- Prescribed burn of entire Ring Island habitat (February 27)
- Manual extraction (hand pulling, burr removal) immediately preceding nesting season on Ring Island (March 13 and April 4)
- Control and salt solution treatment (10% salt concentration) plots (1 m<sup>2</sup>) randomly assigned along six transects
  - 23 treatment plots, 25 control plots
  - \* Treatment plots received repeated salt solution spray (12x throughout season), control plots did not receive salt solution spray
- Vegetation metrics measured in each plot before (April/May) and after the treatment period (July/August)
  - Species ID
  - Braun-Blanquet cover classes (total plot and each species)
  - Length of live stems for dominant species

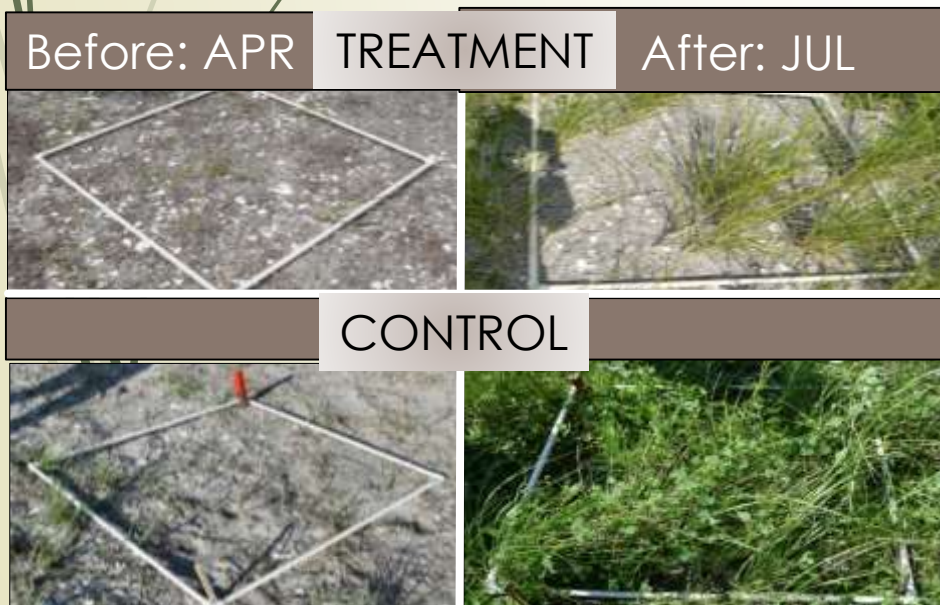
Fig. 1. Mean number of species by phase (pre or post-treatment) and plot (control or treatment) on Ring Island.

- Application of salt spray successfully reduced vegetation growth and controlled ground cover
  - Lower species diversity for vegetation within treatment plots compared to control plots at the end of the season (Fig. 1)
  - Reduced vegetation cover within treatment plots compared to control plots at the end of the season (Fig. 2)

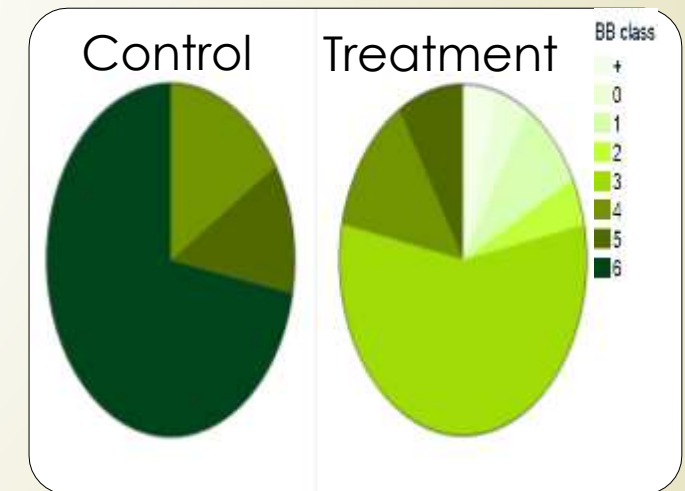
Fig. 2. Live vegetation Braun-Blanquet cover classes post-treatment by plot type on Ring Island.

+= less than 1%, 0= 0%, 1: 1% to 5%, 2: 6% to 10%, 3: 11% to 25%, 4: 26% to 50%, 5: 51% to 75%, 6: 76% to 100%

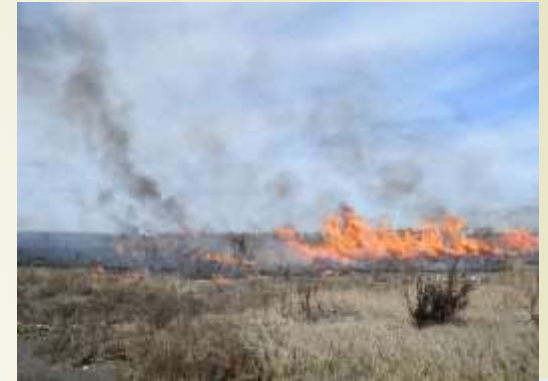
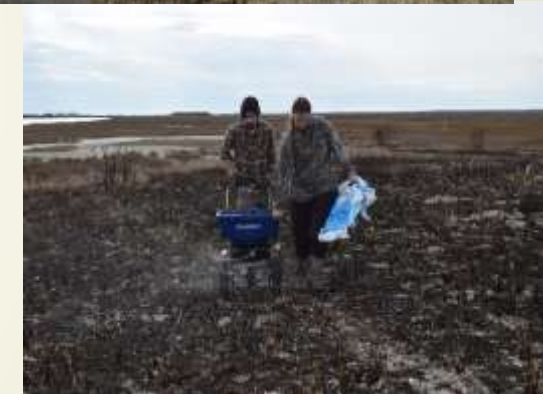
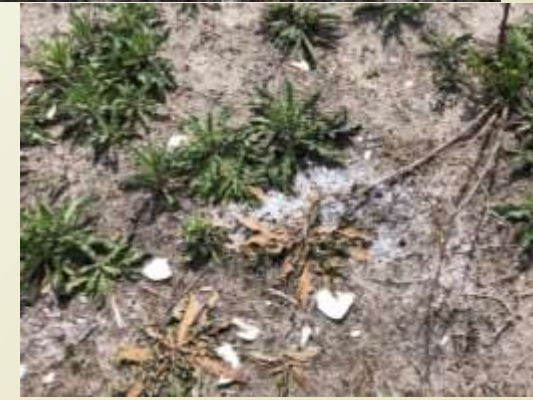
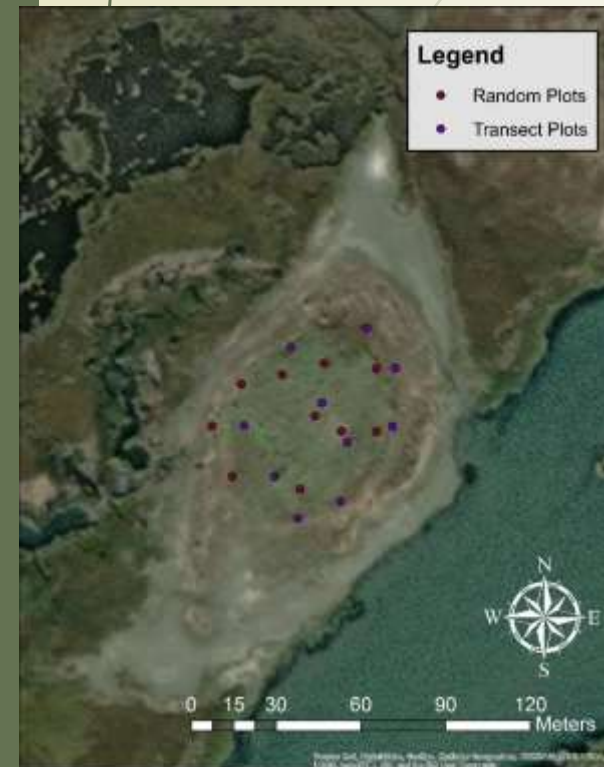
- Prescribed burn of entire Ring Island habitat (January 30)
- No manual removal of vegetation
- Direct placement of salt on the entire Ring Island habitat on two occasions before (February) and during (April) nesting season
- Collected vegetation metrics within 1m<sup>2</sup> plots (n=20) on ENH at the end of the nesting season to allow for comparisons with 2019 control plots (no pre-season metrics)

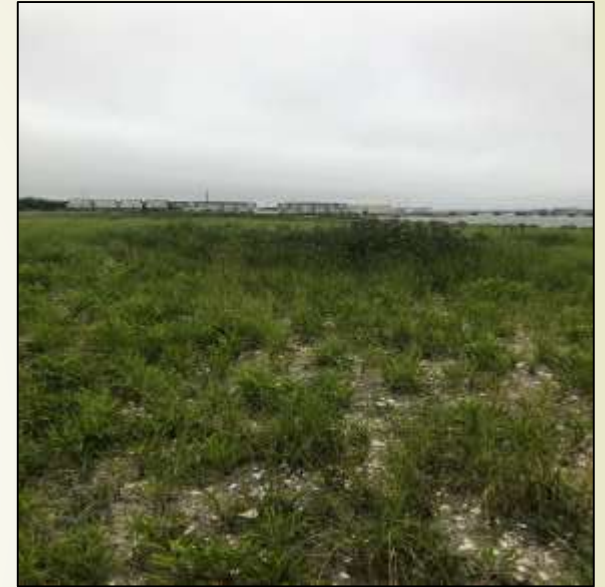
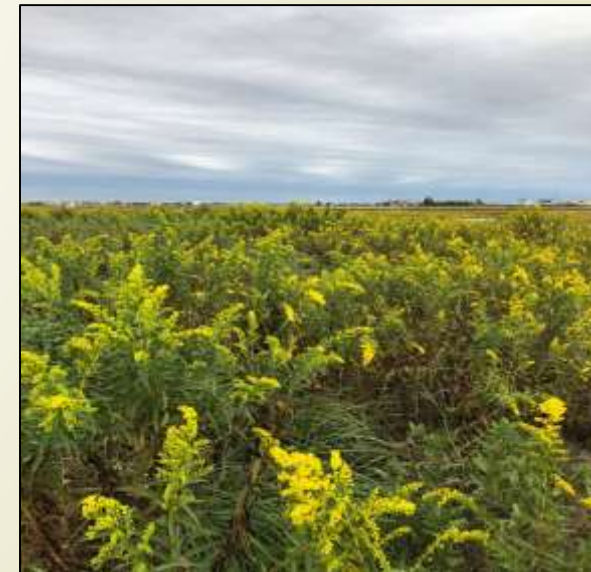
## VEGETATION MANAGEMENT RESULTS

- Cover classes observed within ENH plots in 2020 were similar to control plots in 2019 ( $\pm$  SE)
  - $5.56 \pm 0.34$  (2019 control)
  - $5.60 \pm 0.34$  (2020)
- Average ( $\pm$  SD) species richness within all plots was  $4.4 \pm 1.2$  species – slightly lower than observed in control plots on Ring ENH in 2019 ( $5.0 \pm 1.3$  species)
  - **Combination of prescribed burn and spreading salt on Ring ENH habitat was not effective in controlling vegetation**

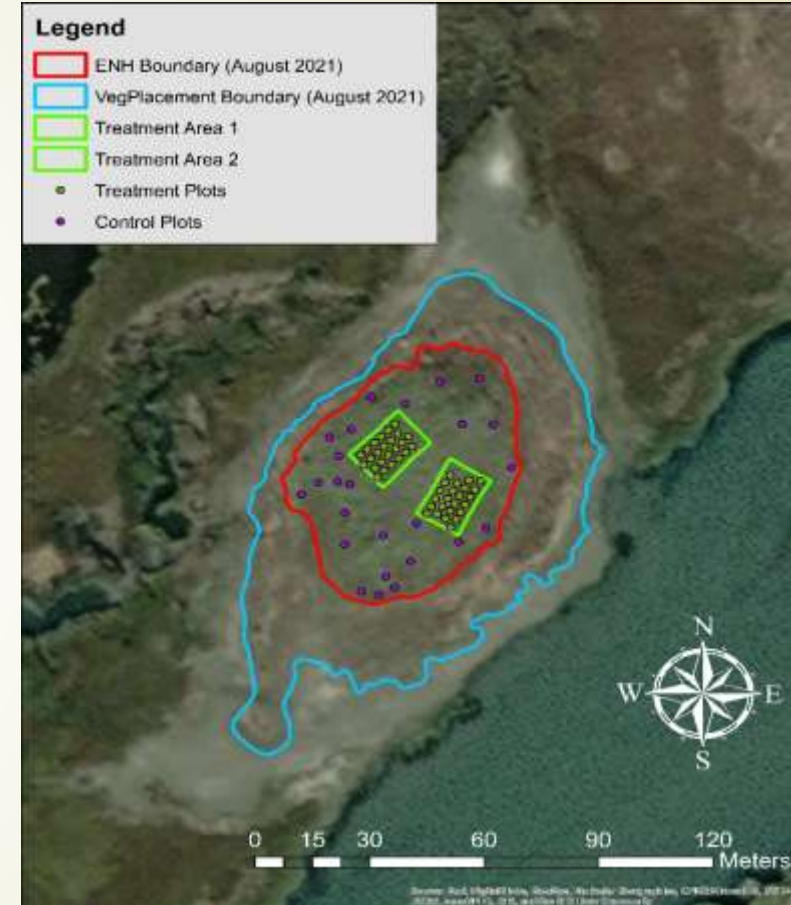
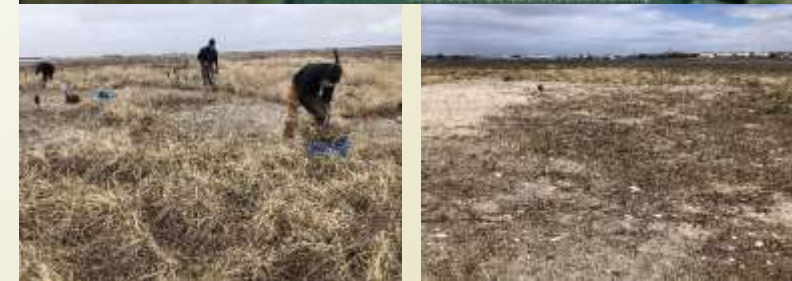
- No prescribed burns
  - Dense vegetation established during the nesting season after burns in 2019 and 2020
- Manual removal of vegetation within two 160m<sup>2</sup> areas prior to nesting season (March/April)
- Repeated spray (n=5) of concentrated salt solution within one of the treatment areas throughout nesting season (April-July)
- Collected vegetation metrics at the start and end of the nesting season within 1m<sup>2</sup> plots
  - ✓ Plots established along transects within treatment areas (n=24 per treatment area)
  - ✓ Plots randomly selected within the ENH control area (n=25)

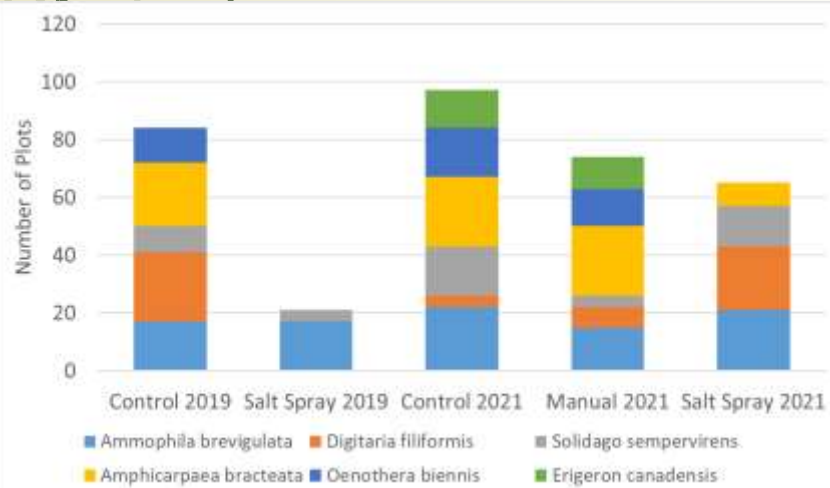
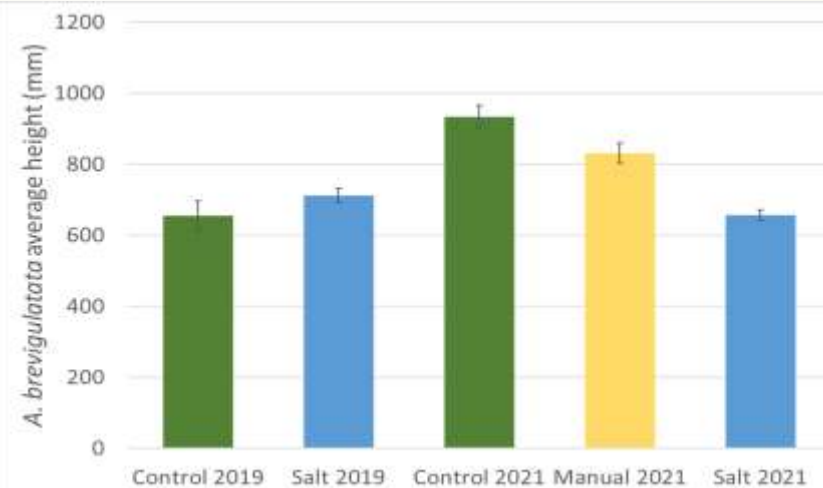
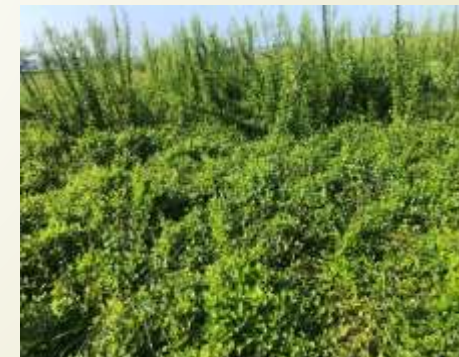
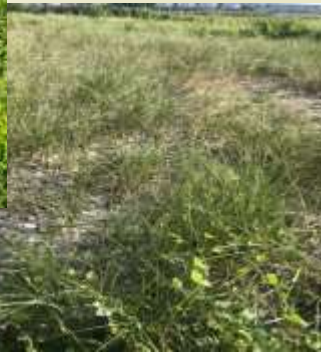
## SALT SPRAY STUDY COMPARISONS

- Vegetation cover similar within control areas on ENH for all years of the study
- American hog peanut (*Amphicarpaea bracteata*) most dominant species in control and manual removal only plots
- American beachgrass (*Ammophila brevigulata*) most dominant species in salt spray plots
- Salt spray plots in 2021 observed with more crabgrass (*Digitaria filiformis*), Seaside goldenrod (*Solidago sempervirens*), and American hog peanut compared to 2019
- American beachgrass similar height between saltwater and control plots in 2019; significantly lower height in saltwater + manual removal compared to manual and control plots in 2021

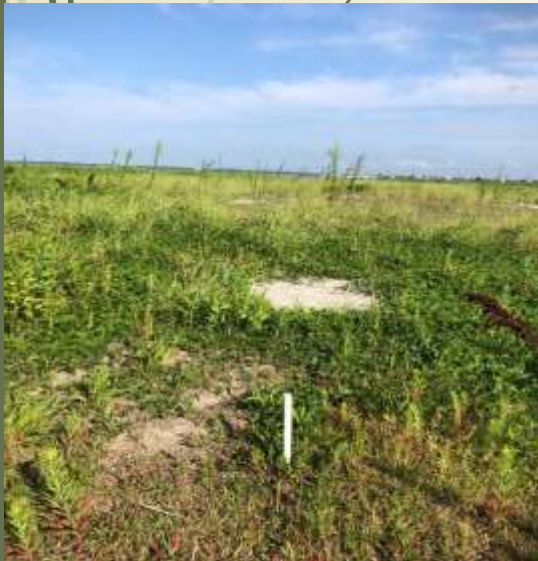
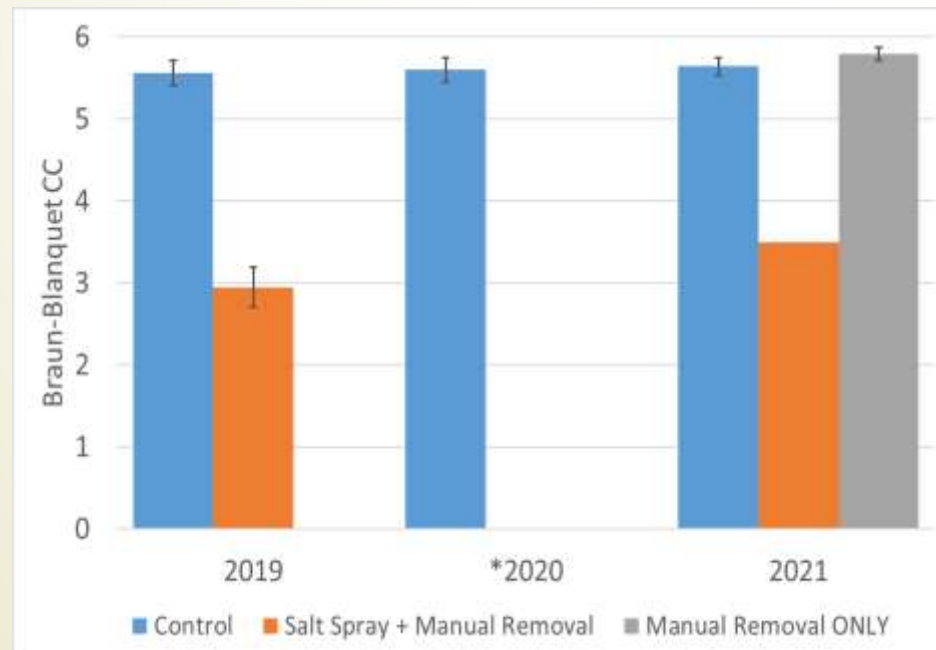
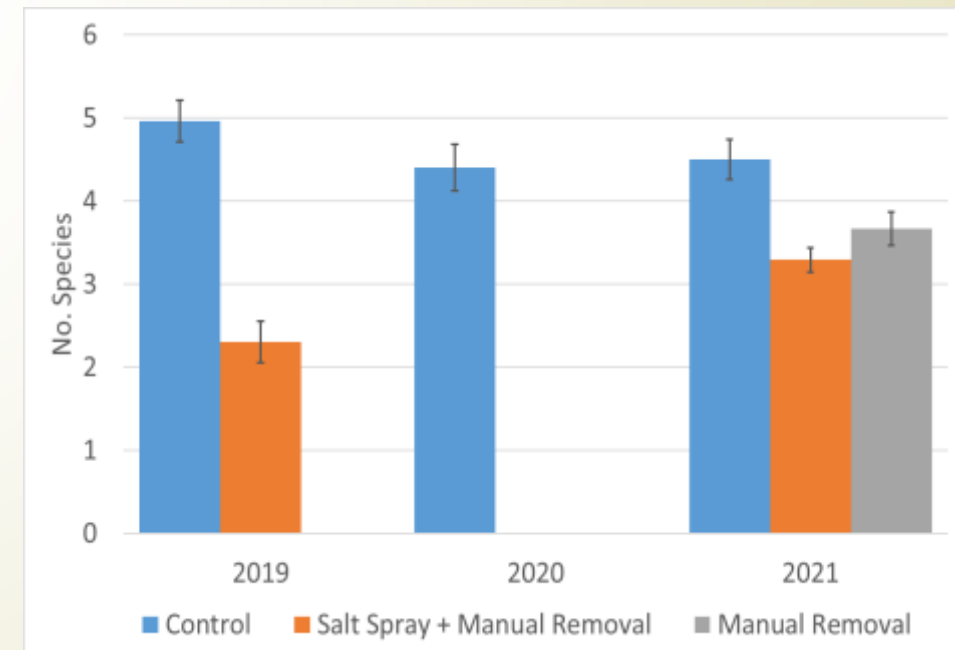
## VEGETATION MANAGEMENT

- Vegetation cover similar within control areas on ENH for all years of the study (>50%)
- Average number of species similar within control areas on ENH for all years of the study (4-5 species)
- Salt spray plots with significantly lower CC and species diversity both years of the treatment study
- Manual removal only with similar CC to control plots but lower species diversity
